District Factsheet

Rural and Small Town Water Services

Builsa South

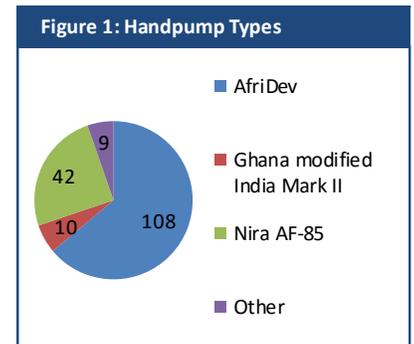
Table 1 and Figure 1 give an overview of the number and types of water supply facilities in the rural communities and small towns in the district.

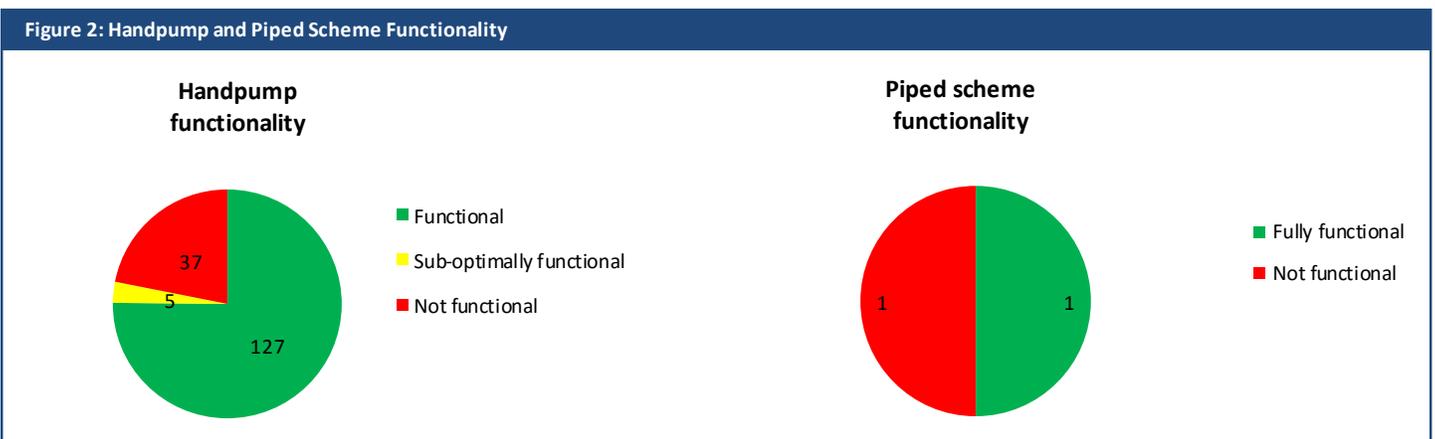
Figure 2 gives an overview of the functionality of water supply facilities in rural communities and small towns in the district.

A handpump is considered fully functional if water flows within 5 strokes, sub-optimally functional if it takes more than 5 strokes for water to flow and not functional if water does not flow.

A piped scheme is considered fully functional if all its sources are functional, sub-optimally functional if one or more of its sources are not functional, and not functional if none of its sources are functional.

Out of the 2 piped schemes in the district, 1 was found functional.

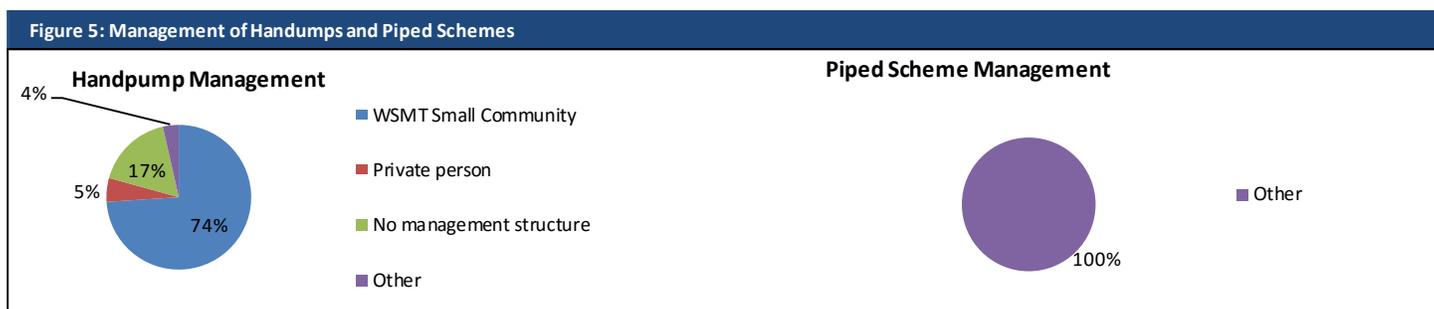
Figure 5 shows the different types of handpump and piped scheme management in the district. The performance of Water and Sanitation Management Teams have been assessed against indicators and benchmarks in relation to governance, operations and financial management. Benchmarks have been set based on national guidelines. Table 4 presents the proportion of Water and Sanitation Management Teams for Small Communities (WSMTs-SC) which meet the benchmark on these indicators in the district. The proportion of Water and Sanitation Management Teams for Small Towns (WSMT-ST) meeting the benchmark on each indicator is presented in Table 5.
