District Factsheet

Rural and Small Town Water Services

June 2016

Bawku West

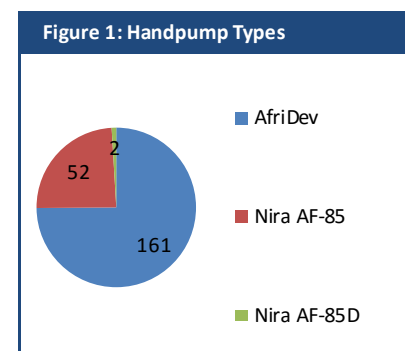
Table 1 and Figure 1 give an overview of the number and types of water supply facilities in the rural communities and small towns in the district.

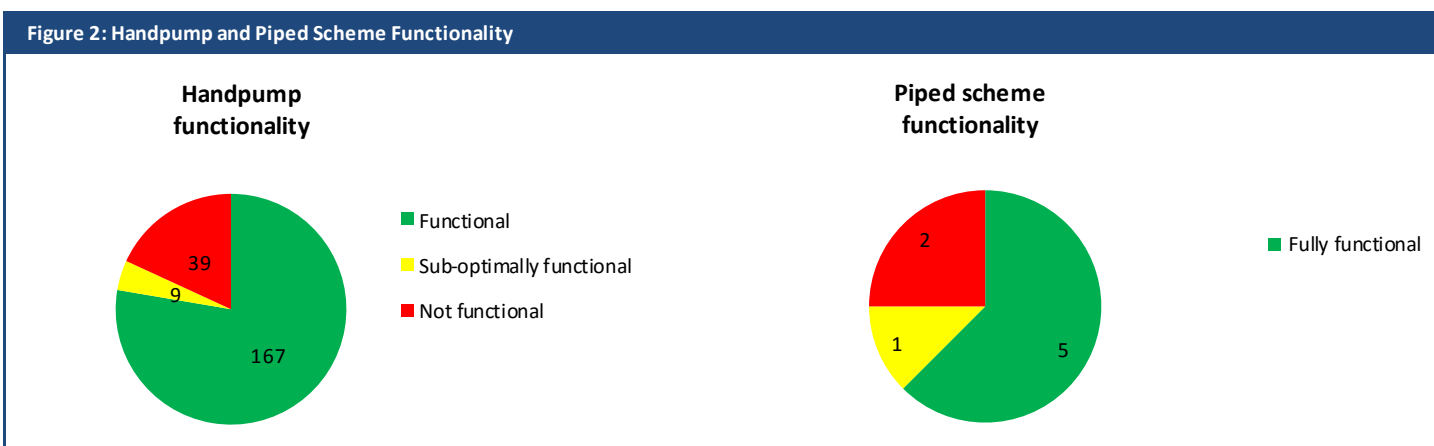
Figure 2 gives an overview of the functionality of water supply facilities in rural communities and small towns in the district.

A handpump is considered fully functional if water flows within 5 strokes, sub-optimally functional if it takes more than 5 strokes for water to flow and not functional if water does not flow.

A piped scheme is considered fully functional if all its sources are functional, sub-optimally functional if one or more of its sources are not functional, and not functional if none of its sources are functional.

Handpump functionality in the district was 78%.

Out of the 8 piped schemes in the district, 6 were functional.

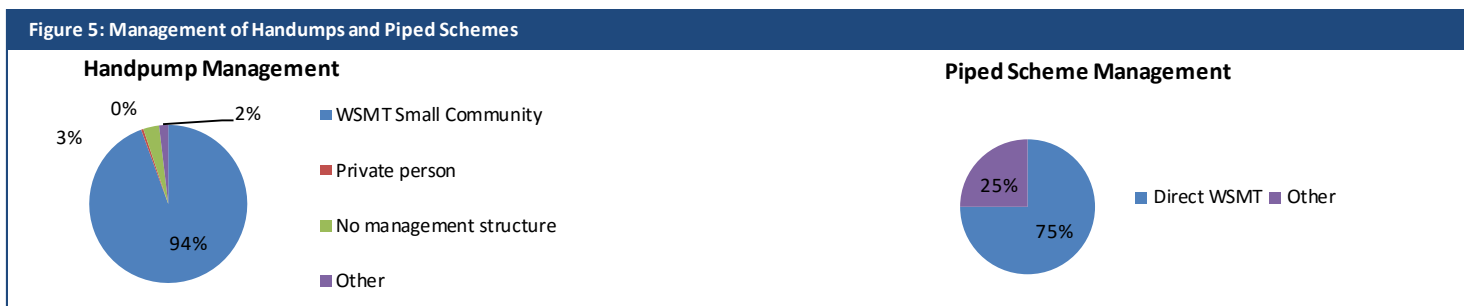
Figure 5 shows the different types of handpump and piped scheme management in the district. The performance of Water and Sanitation Management Teams have been assessed against indicators and benchmarks in relation to governance, operations and financial management. Benchmarks have been set based on national guidelines. Table 4 presents the proportion of Water and Sanitation Management Teams for Small Communities (WSMTs-SC) which meet the benchmark on these indicators in the district. The proportion of Water and Sanitation Management Teams for Small Towns (WSMT-ST) meeting the benchmark on each indicator is presented in Table 5.
